**MERRYCHEF TECH ASSIST APP
AVAILABLE ON APPLE & GOOGLE**

Tech Advisory Number: TAMCF00026

This TA describes the new features, updates, and bugs in the latest firmware version for Merrychef connex.

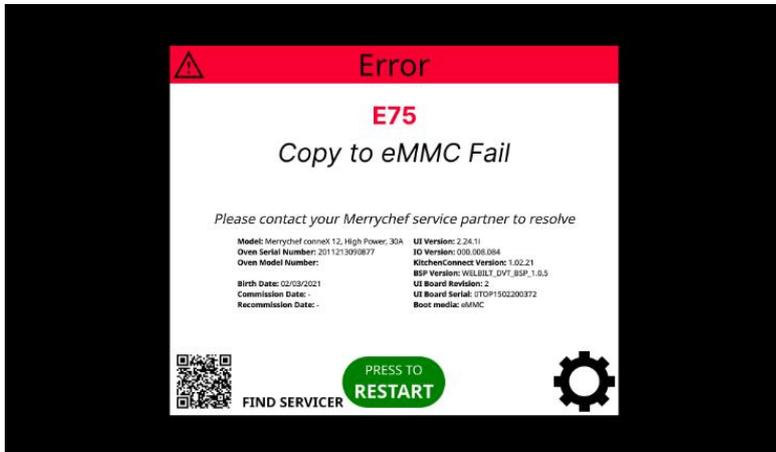
Figure 1 eMMC error pop-up

1.0. New error code E75 Copy to eMMC fail

When the oven is powered on for the first-time during installation or has been updated to this new revision, the SD card contents is copied over to the eMMC. The UI will run the copy twice and if it fails after two attempts, an E75 error pop-up is displayed.

If the eMMC copy cannot be completed, the oven will continue to run from the SD card as normal.

Merrychef asks if the witness of a failure could photograph the E75 error pop-up and forward the photo on to merrychef.techsupport@welbilt.com

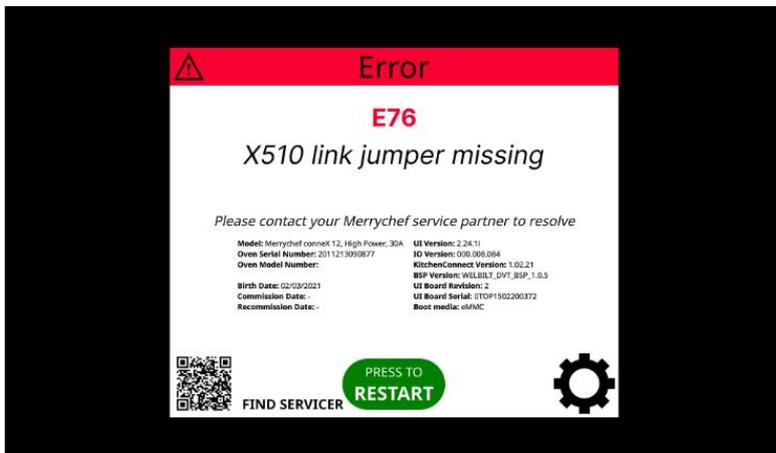
Figure 2 E76 error pop-up

2.0. New error code E76 I/O X510 missing.

I/O input X510 is what would be used if the conneX oven had a power switch for the 12Vdc, like the e2s. On conneX, because there is no physical switch, the 12Vdc needs to be shorted using a link jumper. If the input is not shorted, an E76 pop-up will display.

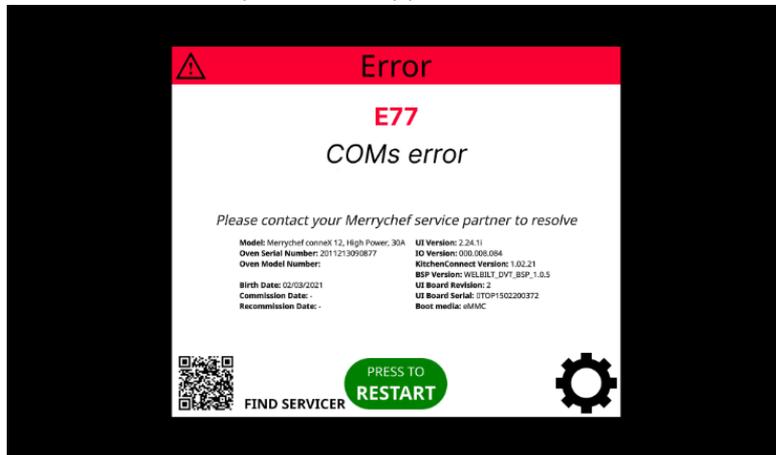
Figure 3 E77 error pop-up

3.0. New error code E77 and updates to existing code E107 COMs error

E77 is triggered by the UI when no signal has been detected from the IO for 10 seconds and would most likely be caused by a failure of the UI comms cable.

E107 is triggered when the IO doesn't get a response from the UI within 1/3rd of a second, which can't be transmitted to the UI if comms are out. In this case, the UI will have also generated an E77.

It is possible the UI has become slow to respond, in which case the E107 will be recognised by the UI at some point and an error pop-up generated.

Slow UI response has been responsible for E107s being generated in previous firmware versions and we have dealt with a lot of the underlying causes of sluggish UI but there may still be more issues we haven't recognised yet.

We should be informed when a system is generating E107 because we'd want to understand the underlying issue. Contact merrychef.techsupport@welbilt.com

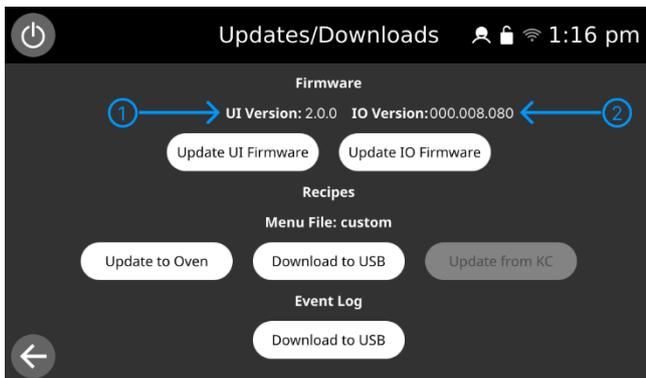
Figure 5 Old Update Page

Despite our best efforts and thorough firmware regression testing, a bug has been found which will be fixed in our next release of firmware. When updating the firmware to the latest release, in some cases we have found the new UI firmware version number is not displayed after the update has been completed.

In the Old firmware updates page, both the UI Version (1) and the IO version (2) are visible.

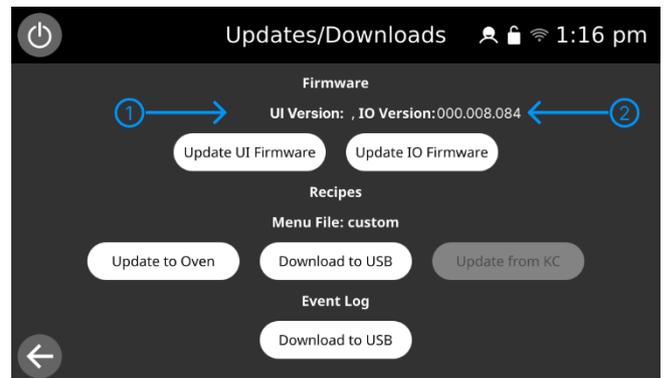
Figure 6 New Updates page

After completing the update, the version number might not be displayed. In the New firmware updates page, the IO Version (2) has updated.

To confirm the UI firmware has updated, the about page can be referenced before and after the update.

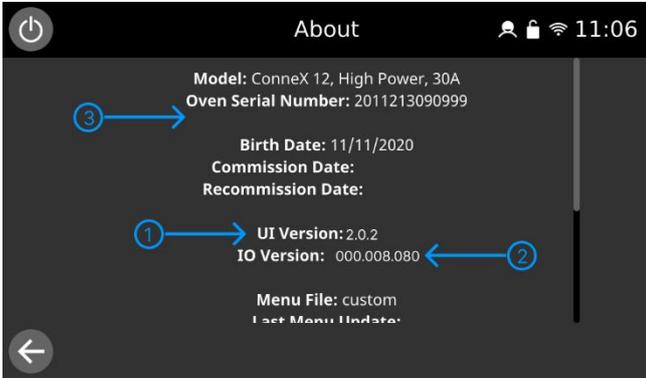
Figure 7 Old About page

The About screen before the update does not include oven model number (3), as this was not a feature in the older version of software.

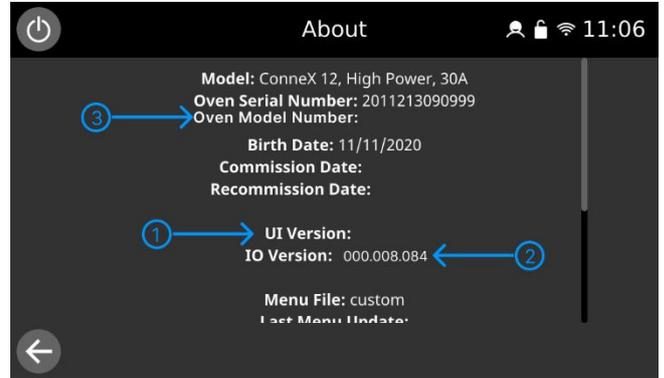
Figure 8 New About page

(Note: The model number gets populated during the factory setup process. It's blank because this feature did not exist in older versions of the oven firmware when the oven was built. It has no impact on the operation of the oven.)
