**MERRYCHEF TECH ASSIST APP
AVAILABLE ON APPLE & GOOGLE**

Tech Advisory Number: TAMCF00026

This TA describes the new features, updates, and bugs in the latest firmware version for Merrychef connex.

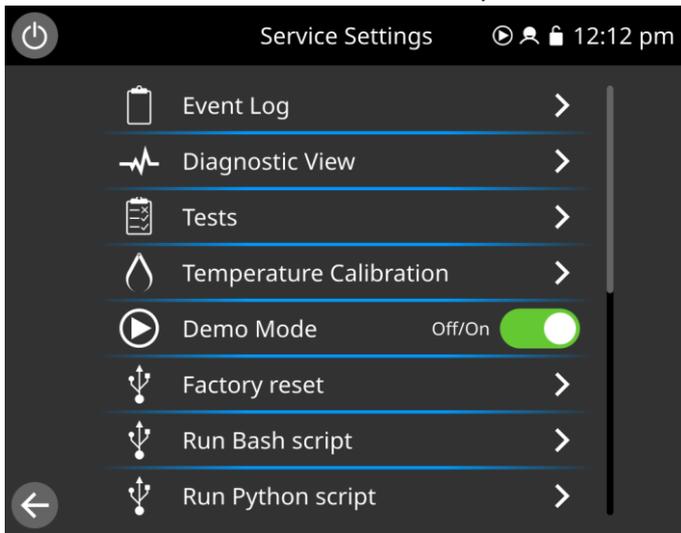
Figure 4 New diagnostic features

In service settings, are two new features to help the Merrychef software team run diagnostics, Run Bash Script and Run Python script. Authorised usage of these features is limited to Merrychef software trained technicians. This feature will only be utilised under explicit instruction from Merrychef Technical Services, and any unauthorized access may result in invalidation of warranty.
